DAM EVALUATION REPORT

WILLOW LAKE DAM

Yaphank, New York

November 16, 2012

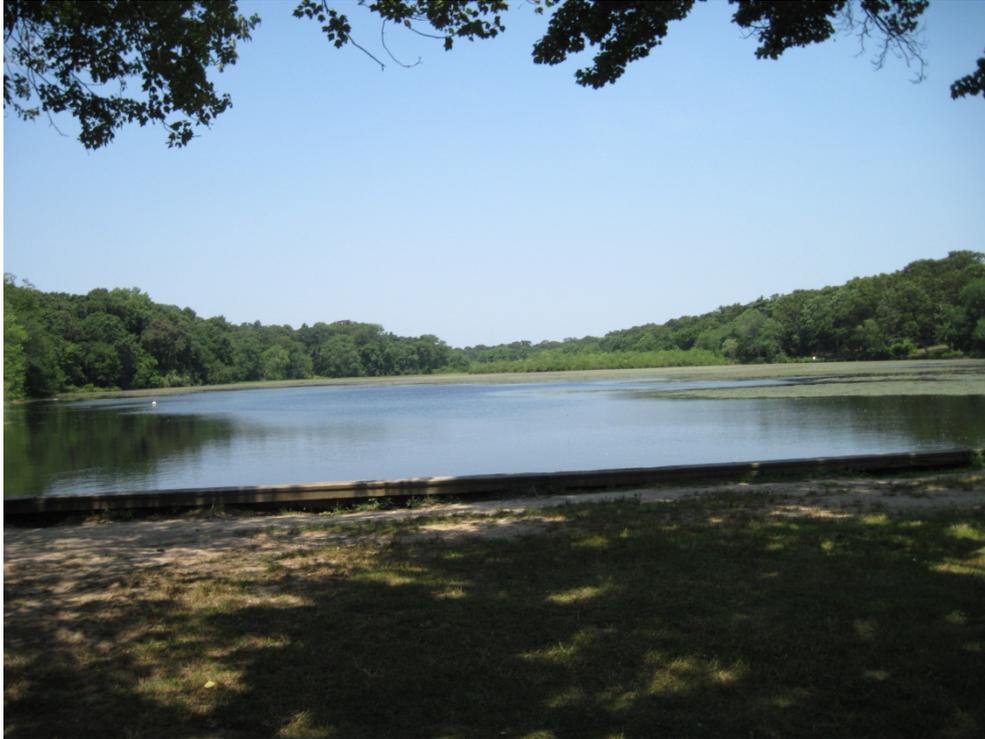
The Willow Lake Dam is an earthen embankment dam located at the downstream end of Willow Lake (Photo 1). The dam consists of an earth embankment, spillway, and a low level outlet. The dam is within a municipal park with extensive public access and use. The Carmans River watershed upstream of the dam is approximately 70 square miles.

Photo # 1: Willow Lake Dam and Impoundment

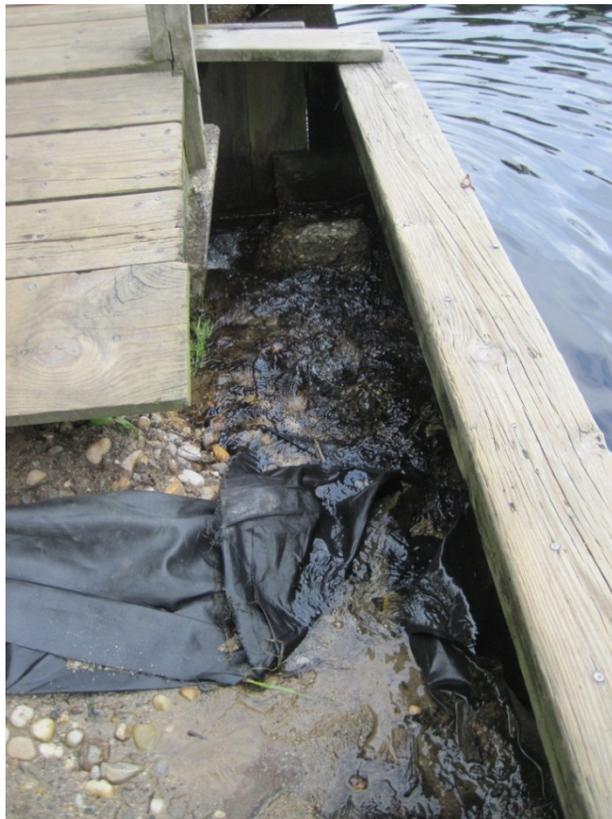
The left embankment is earth reinforced with wooden bulkhead, which extends for 200 feet to the east. A 2 inch by 8 inch wood board caps the bulkhead along its length. The crest of the wooden bulkhead is generally at elevation 38.1, 1.1 feet above normal pool level. There is a significant seepage through a hole in the wooden bulkhead at the left corner transition from the timber sheeting to the spillway channel (Photo 2).

Photo # 2: Seepage through wooden bulkhead

1. Monitor and/or repair earth erosion through holes in timber.
2. Repair seepage at spillway left corner transition from timber sheeting to spillway channel.

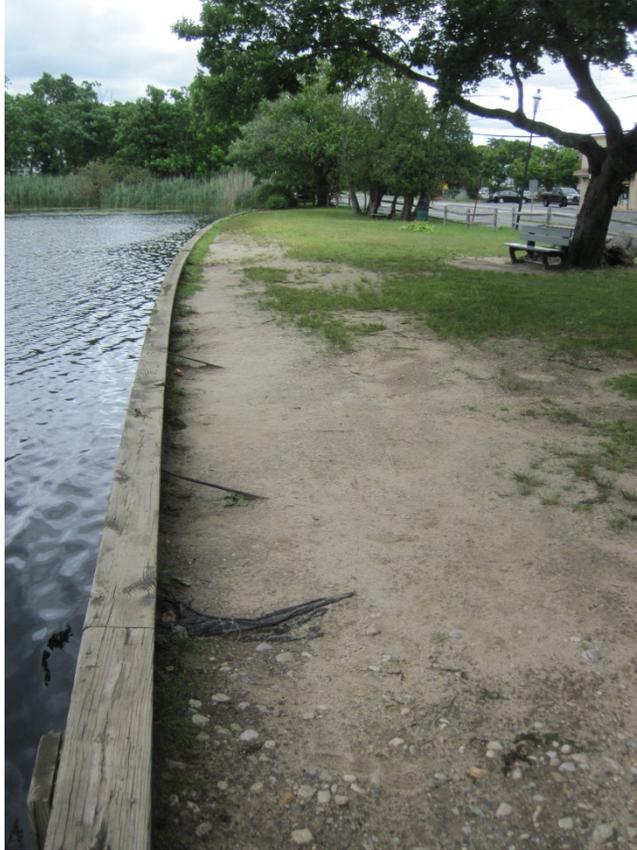
Steel tie-backs anchor the bulkhead to the embankment. Embankment erosion has exposed the tie-backs in numerous places (Photo 3). The embankment is used as a public park, with regularly mowed turf grass. The embankment is eroded as a result of drainage in a number of places. Holes in the wooden bulkhead drain through sink-holes on the top of the embankment.

Photo # 3: Exposed steel tie-backs

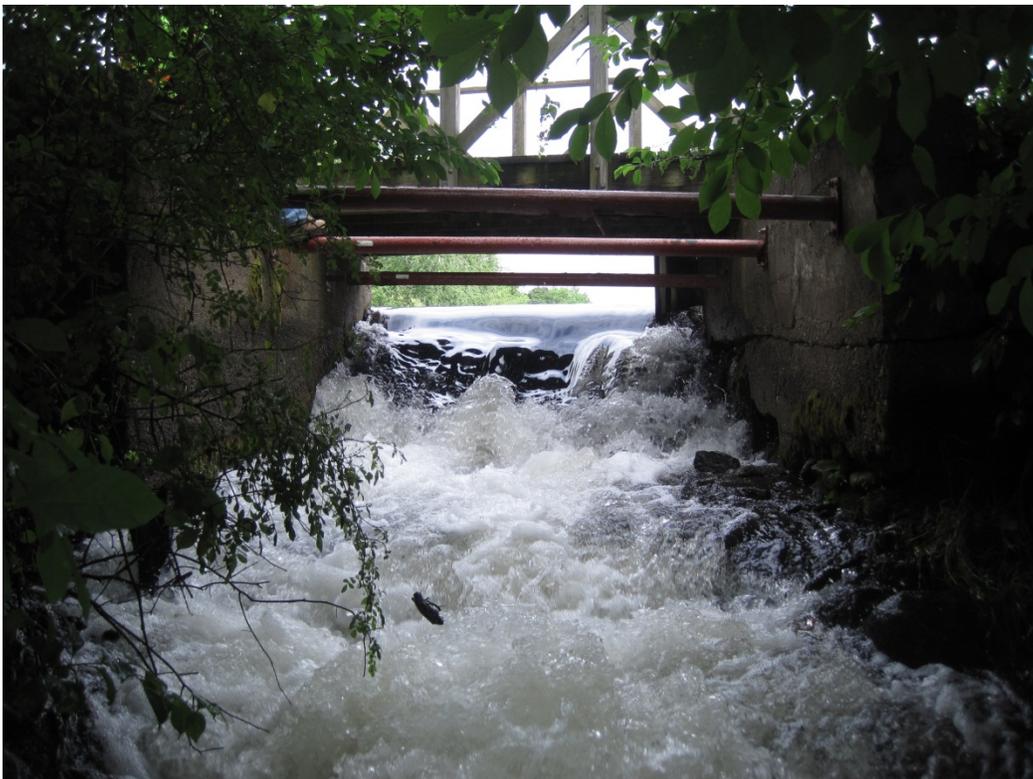
The Willow Lake spillway is a 7.5 foot wide concrete ogee crest with a concrete apron (Photo 4). The crest elevation is 36.4 feet NAVD88. The concrete apron extends 15.5 feet downstream of the spillway, and transitions to large boulder and cobble in the downstream natural channel. There is a large deterioration hole in the upstream face of the concrete spillway. The hole extends from approximately three feet below the spillway crest to the pond bottom. It was not determined if flow was going through the hole in the spillway.

The concrete at the downstream end of the apron is jagged and deteriorated; there is a scour hole at the intersection of the apron and the natural channel.

Photo # 4: Willow Lake spillway

1. Monitor and/or repair leaning training walls.
2. Monitor and/or repair spalling and surface cracks on the wingwall.
3. Repair scourhole at bottom of training walls where it intersects with spillway channel.
4. Repair hole near pond bottom from middle to left about three feet below spillway crest.

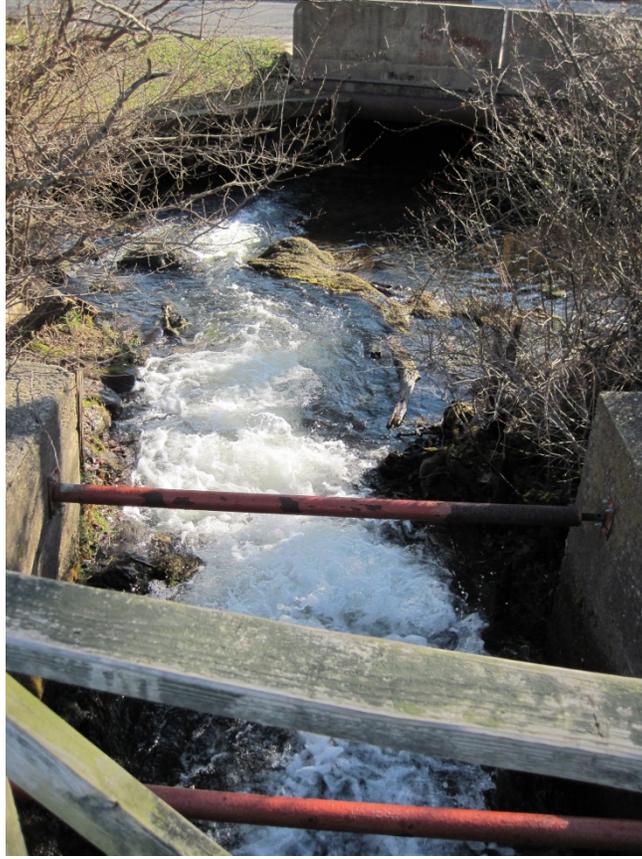
masonry wall. The training walls are leaning inward; three painted screw jack posts are resisting the inward lean (Photo 5). The training walls are heavily scoured at and below the water line along the apron.

Photo # 5: Screw jack posts

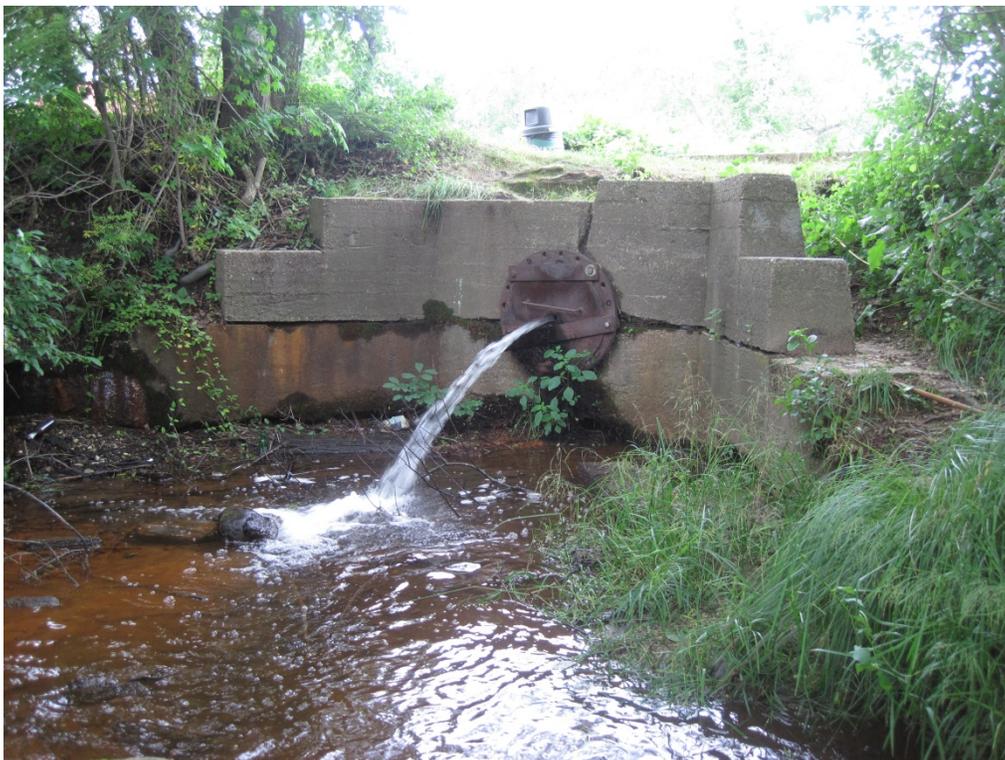
An old 24" steel pipe discharges to the right of the spillway in a concrete stepped headwall with 45° wingwalls. A steel plate is bolted over the downstream face. Water was jetting out of a 1-1/2" hole in the center of the steel plate on the day of inspection (Photo 6). No control works were evident. The pipe is therefore under hydraulic pressure through the dam. The area downstream of low level outlet is a pool and flow joins downstream channel just upstream of bridge.

Photo # 6: Low level outlet

1. Repair steel pipe and plate that is bolted over the downstream face which should be on the upstream face of the dam.
