TOWN OF BROOKHAVEN

Mill Road Culvert Preliminary Hydraulic Analysis Report

April 6, 2018

DAM EVALUATION REPORT

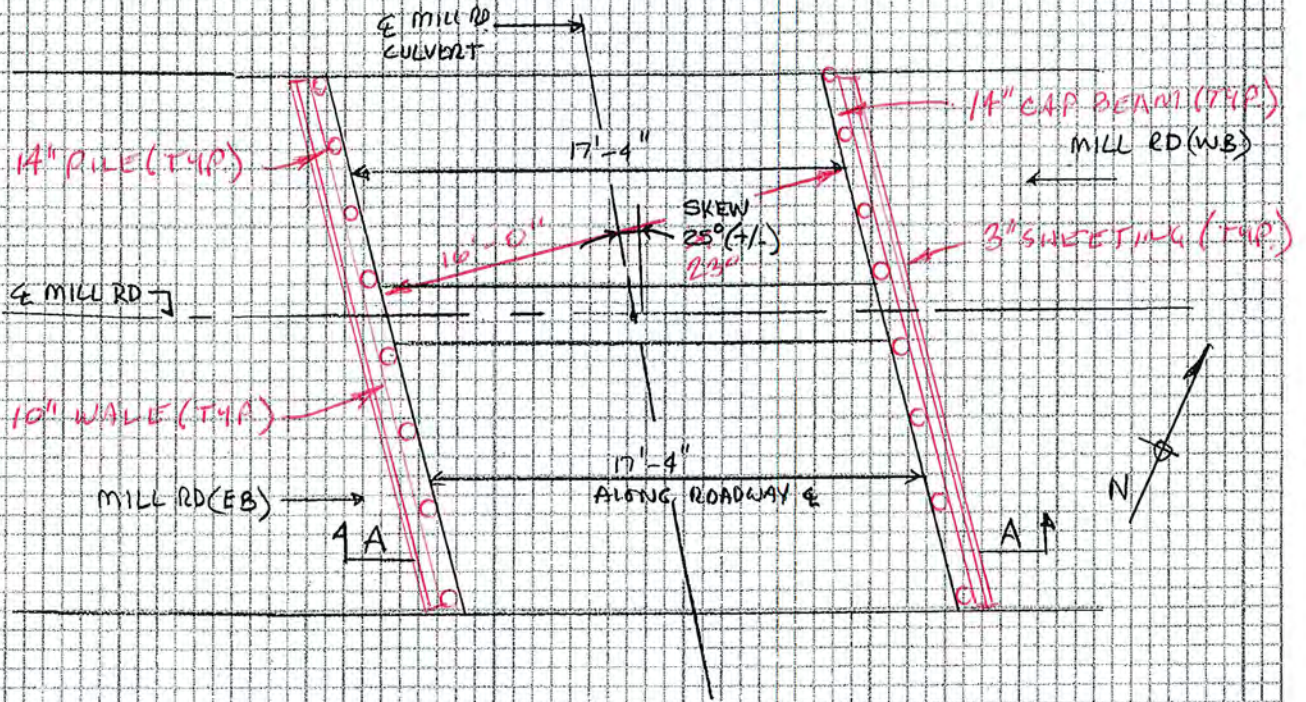
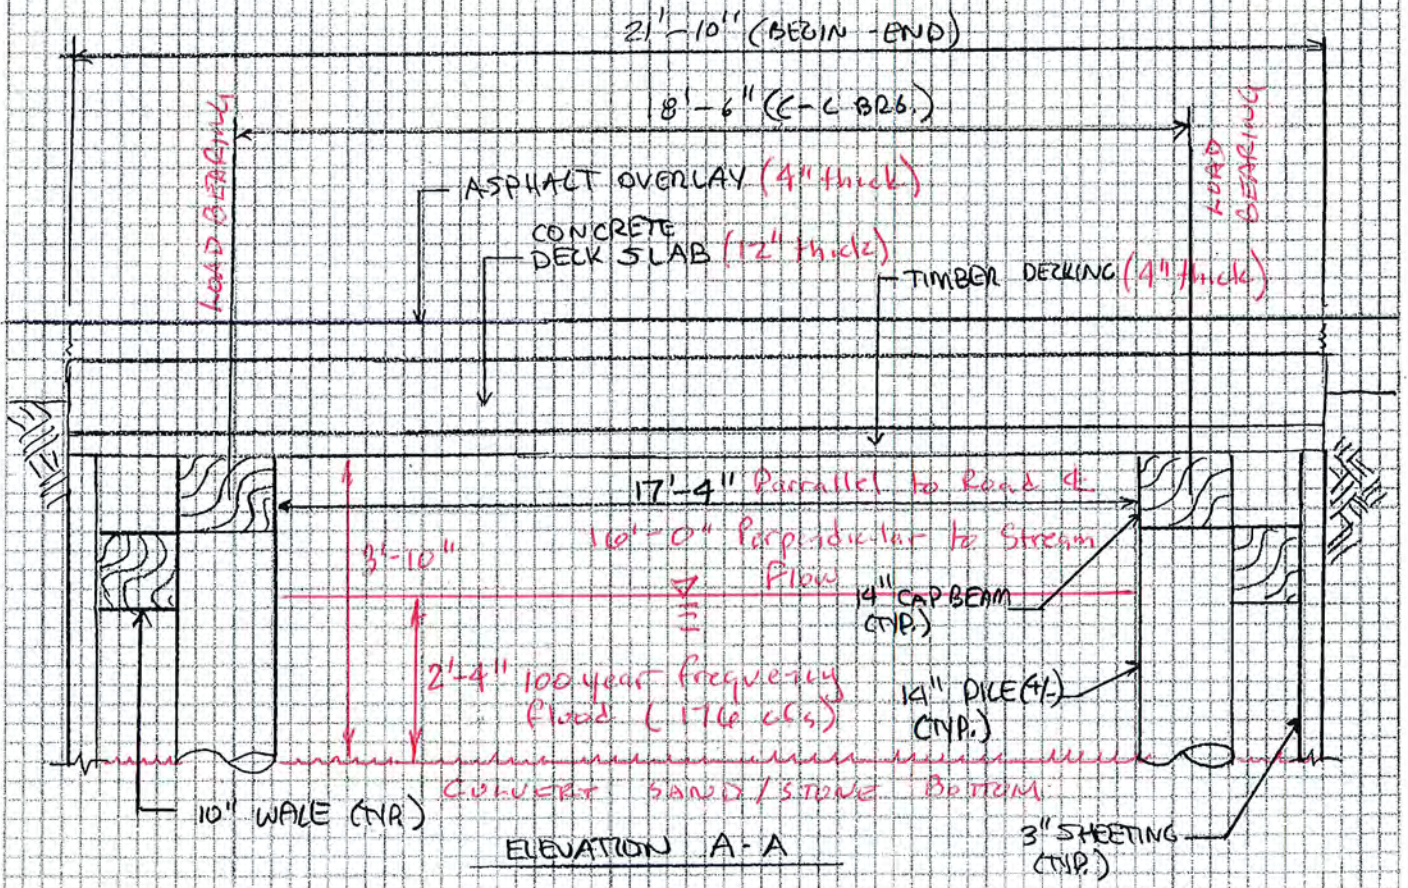
Checked By MILL RD CULVERT GEOMETRY

The measurements of the existing culvert were obtained by the Suffolk County Department of Public Works, Bridge Division in September 2016. As a check, I verified the dimensions, most recently on April 2nd, 2018, to verify the width and heights recorded. It was determined that the measurement of the culvert width, given along the center road line, was skewed from the perpendicular cross section by 23 degrees. The width of the culvert has been calculated to be 16'-0" wide, $\text{Cosine } 23 \text{ degrees} \times 17'-4"$. Attached is a revised sketch showing the calculation and the opening height, also measured.

We also measured the culvert openings, with the upstream side being 3' – 10" high and the downstream side being 2' – 3" high.

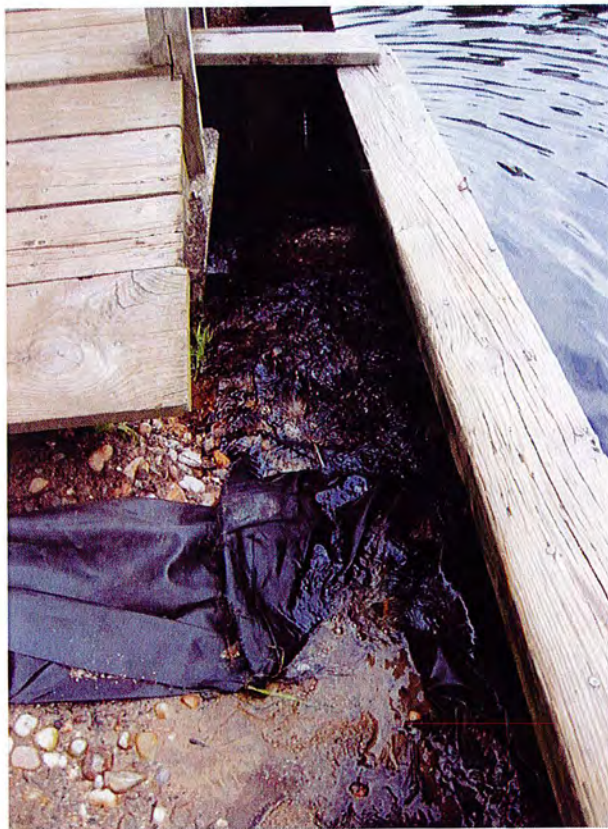
The left embankment is earth reinforced with wooden bulkhead, which extends for 200 feet to the east. A 2 inch by 8 inch wood board caps the bulkhead along its length. The crest of the wooden bulkhead is generally at elevation 38.1, 1.1 feet above normal pool level. There is a significant seepage through a hole in the wooden bulkhead at the left corner transition from the timber sheeting to the spillway channel (Photo 2).

Photo # 2: Seepage through wooden bulkhead

1. Monitor and/or repair earth erosion through holes in timber.
2. Repair seepage at spillway left corner transition from timber sheeting to spillway channel.

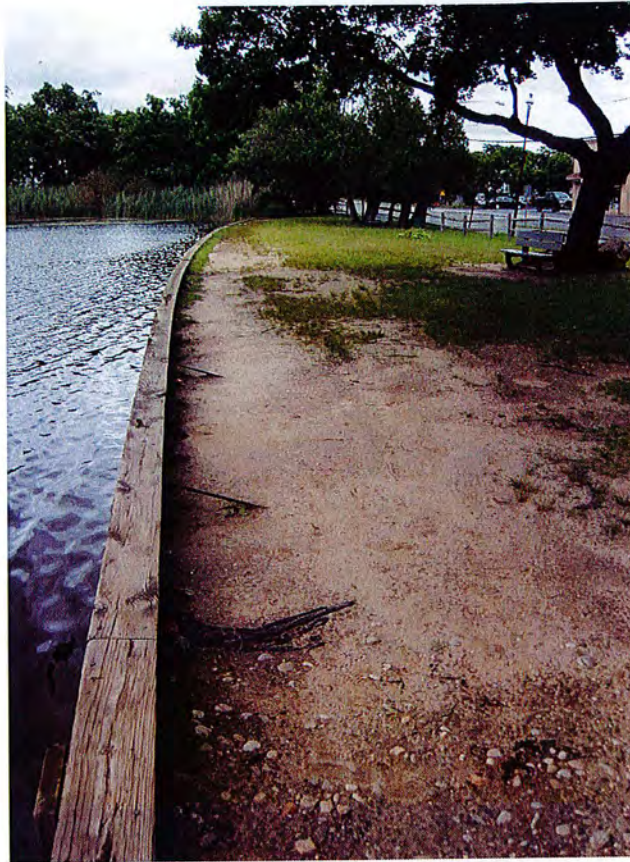
Steel tie-backs anchor the bulkhead to the embankment. Embankment erosion has exposed the tie-backs in numerous places (Photo 3). The embankment is used as a public park, with regularly mowed turf grass. The embankment is eroded as a result of drainage in a number of places. Holes in the wooden bulkhead drain through sink-holes on the top of the embankment.

Photo # 3: Exposed steel tie-backs

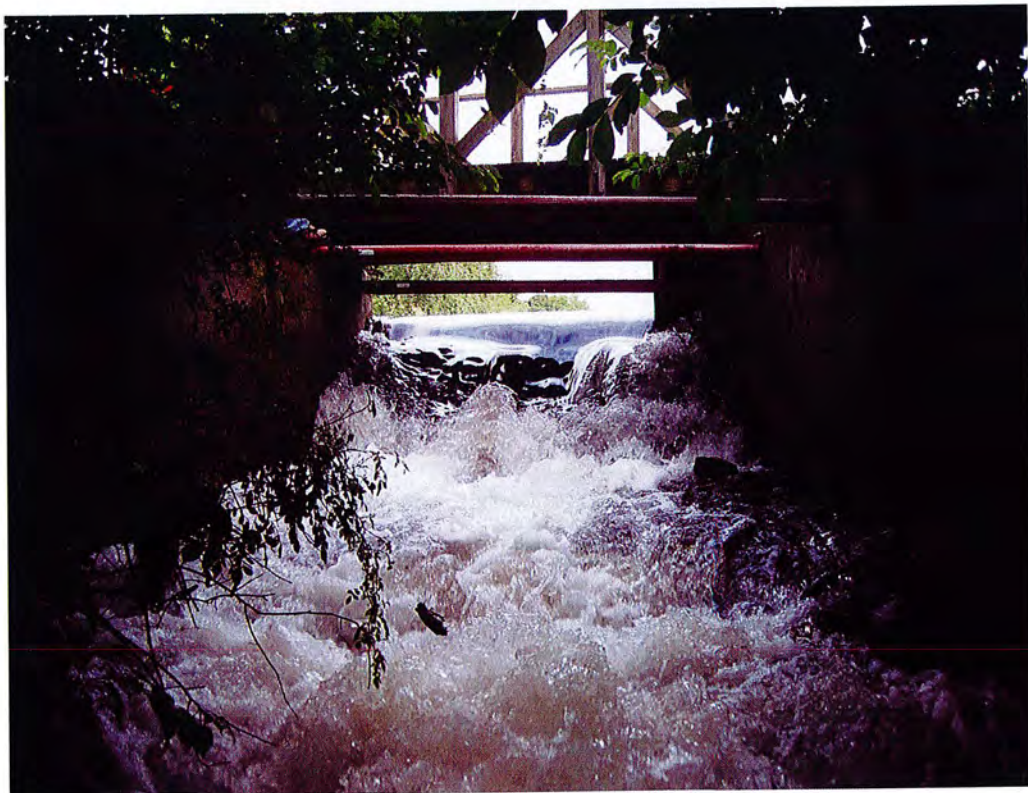
The Willow Lake spillway is a 7.5 foot wide concrete ogee crest with a concrete apron (Photo 4). The crest elevation is 36.4 feet NAVD88. The concrete apron extends 15.5 feet downstream of the spillway, and transitions to large boulder and cobble in the downstream natural channel. There is a large deterioration hole in the upstream face of the concrete spillway. The hole extends from approximately three feet below the spillway crest to the pond bottom. It was not determined if flow was going through the hole in the spillway.

The concrete at the downstream end of the apron is jagged and deteriorated; there is a scour hole at the intersection of the apron and the natural channel.

Photo # 4: Willow Lake spillway

1. Monitor and/or repair leaning training walls.
2. Monitor and/or repair spalling and surface cracks on the wingwall.
3. Repair scourhole at bottom of training walls where it intersects with spillway channel.
4. Repair hole near pond bottom from middle to left about three feet below spillway crest.

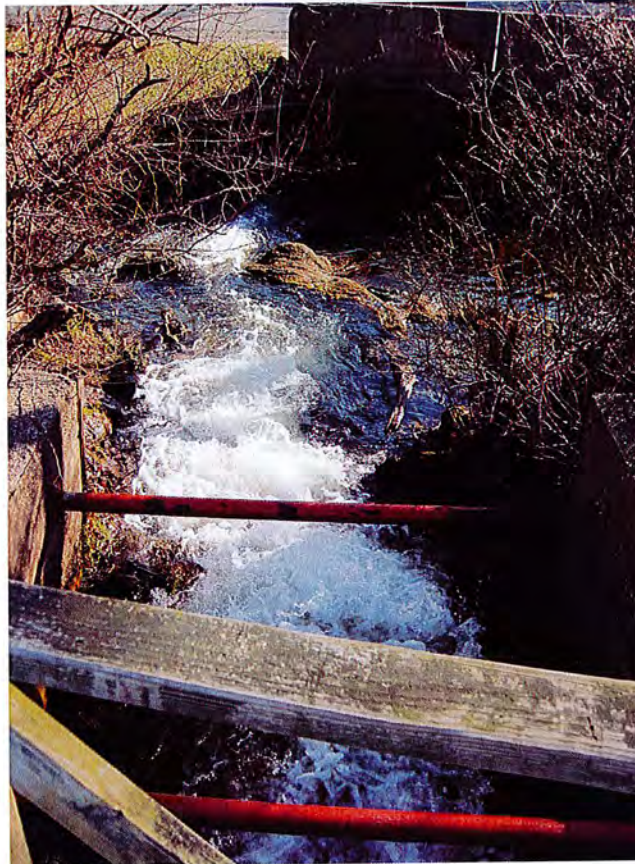
masonry wall. The training walls are leaning inward; three painted screw jack posts are resisting the inward lean (Photo 5). The training walls are heavily scoured at and below the water line along the apron.

Photo # 5: Screw jack posts

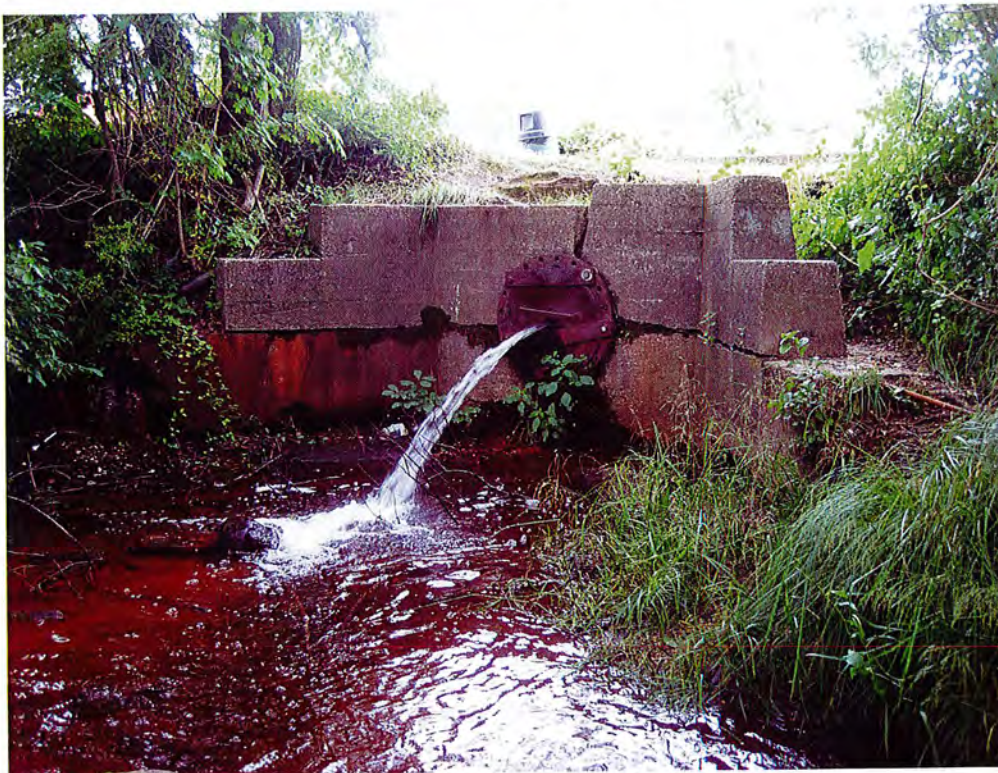
An old 24" steel pipe discharges to the right of the spillway in a concrete stepped headwall with 45° wingwalls. A steel plate is bolted over the downstream face. Water was jetting out of a 1-1/2" hole in the center of the steel plate on the day of inspection (Photo 6). No control works were evident. The pipe is therefore under hydraulic pressure through the dam. The area downstream of low level outlet is a pool and flow joins downstream channel just upstream of bridge.

Photo # 6: Low level outlet

1. Repair steel pipe and plate that is bolted over the downstream face which should be on the upstream face of the dam.
