# Ecological Study to Measure the Effectiveness of Soft Sediment Dredging to Eradicate Invasive and Nuisance Species

Upper Lake – Yaphank, New York

June 2015

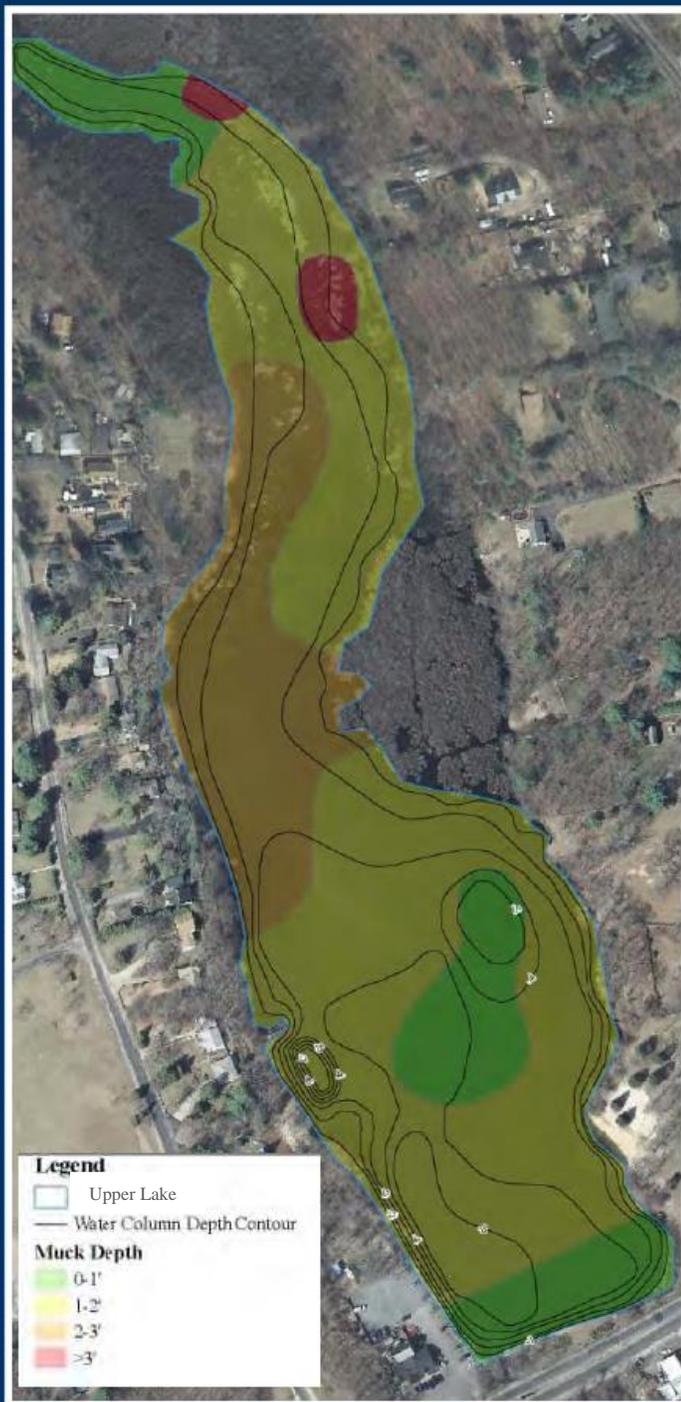
## Bathymetry & Muck Depth – Upper Lake

- Dredging operations may have altered the hard bottom slightly. However, the overall depth did not change dramatically throughout the lake.
- The Fall 2009 (B. Laing) study found soft sediment thickness from zero to greater than three feet. The majority of the lake was found to have a soft sediment thickness from one to three feet, with an area of shoaling in the narrow middle portion of the lake. The June 2015 PWGC study found soft sediment thickness from zero to approximately two and a half feet. The majority of the lake (central and lower portion) was found to be one foot or less, with some areas up to two feet in thickness. A similar area of shoaling was observed in the field in the narrow central portion of the lake.

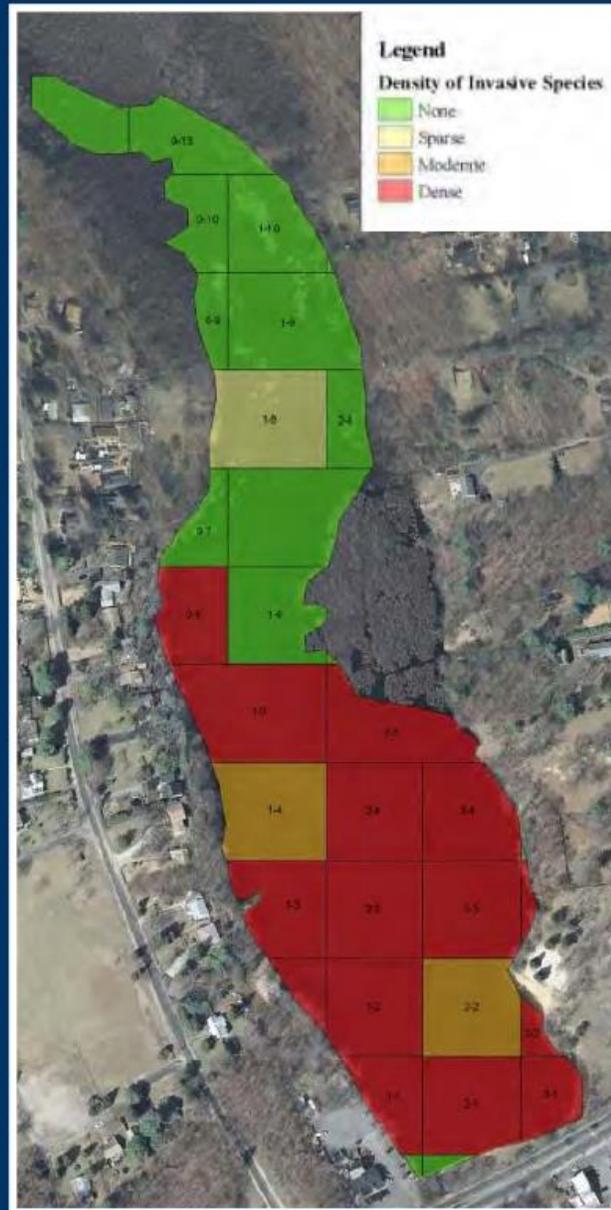
Fall  
2007  
(Town)

# Density of Aquatic Invasive Plants – Upper Lake

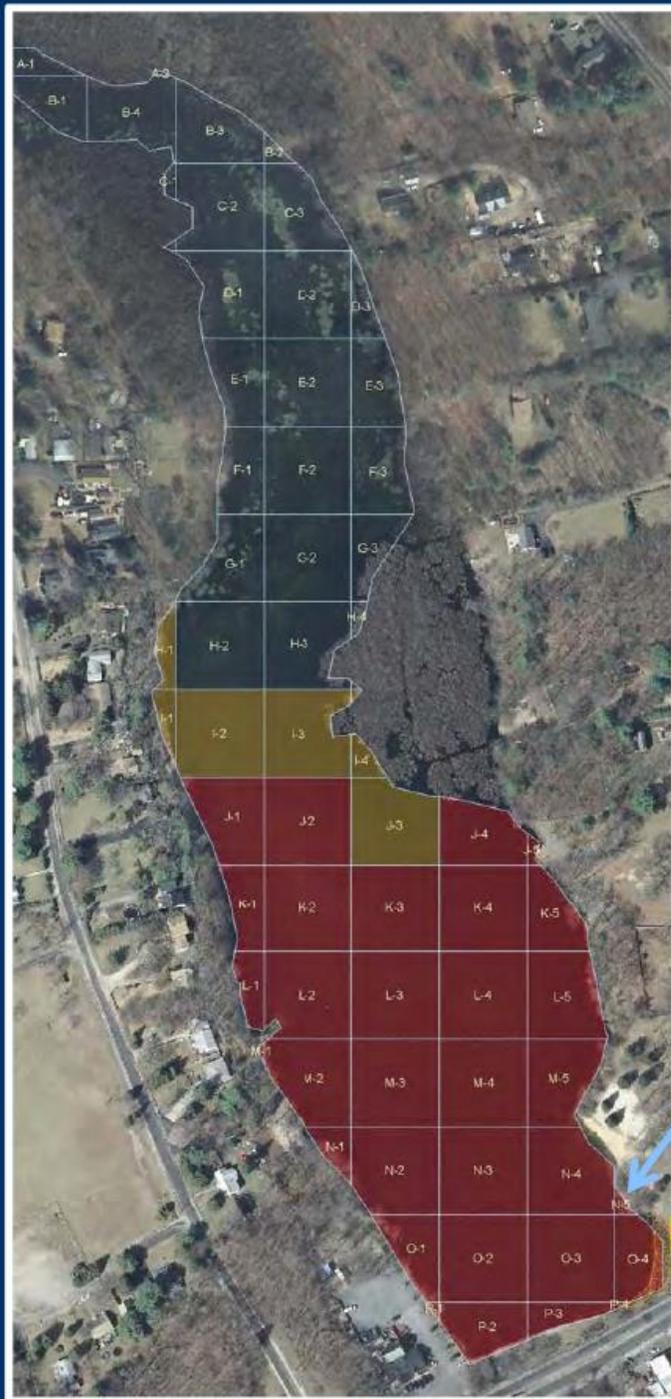
# 2009 Invasive Plant Distribution Map – Upper Lake

- It appears that dredging has removed a significant portion of the soft sediment found in Upper Lake.
- The Fall 2009 (B. Laing) study found invasive aquatic species (*Cabomba Caroliniana* and *Myriophyllum Heterophyllum*) mainly distributed densely throughout the southern portion of the lake. Results of the June 2015 PWGC study indicate that the density and distribution of invasive aquatic species was reduced significantly in the lower portion of the lake. However, an invasive species not previously identified, *Callitriche Stagnalis* was identified in a dense distribution in the middle portion of the lake, north of where the shoaling was observed.

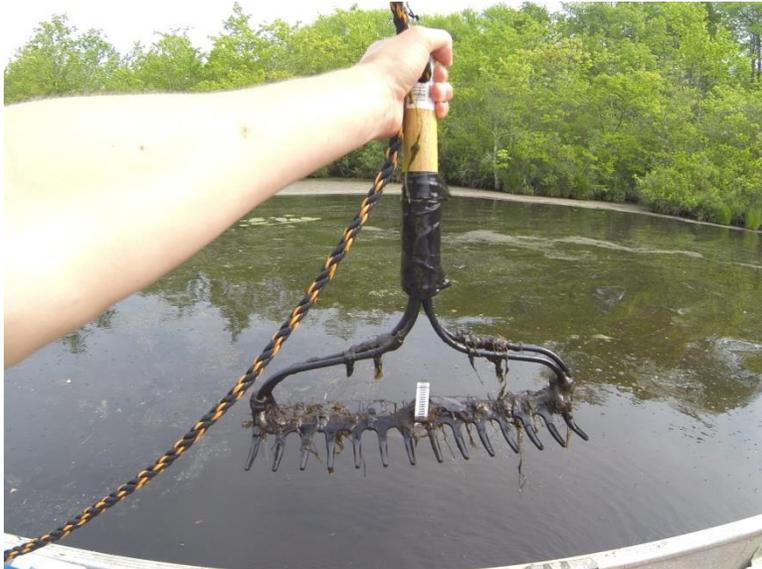
1. Trace

# Rake Toss Density Evaluation

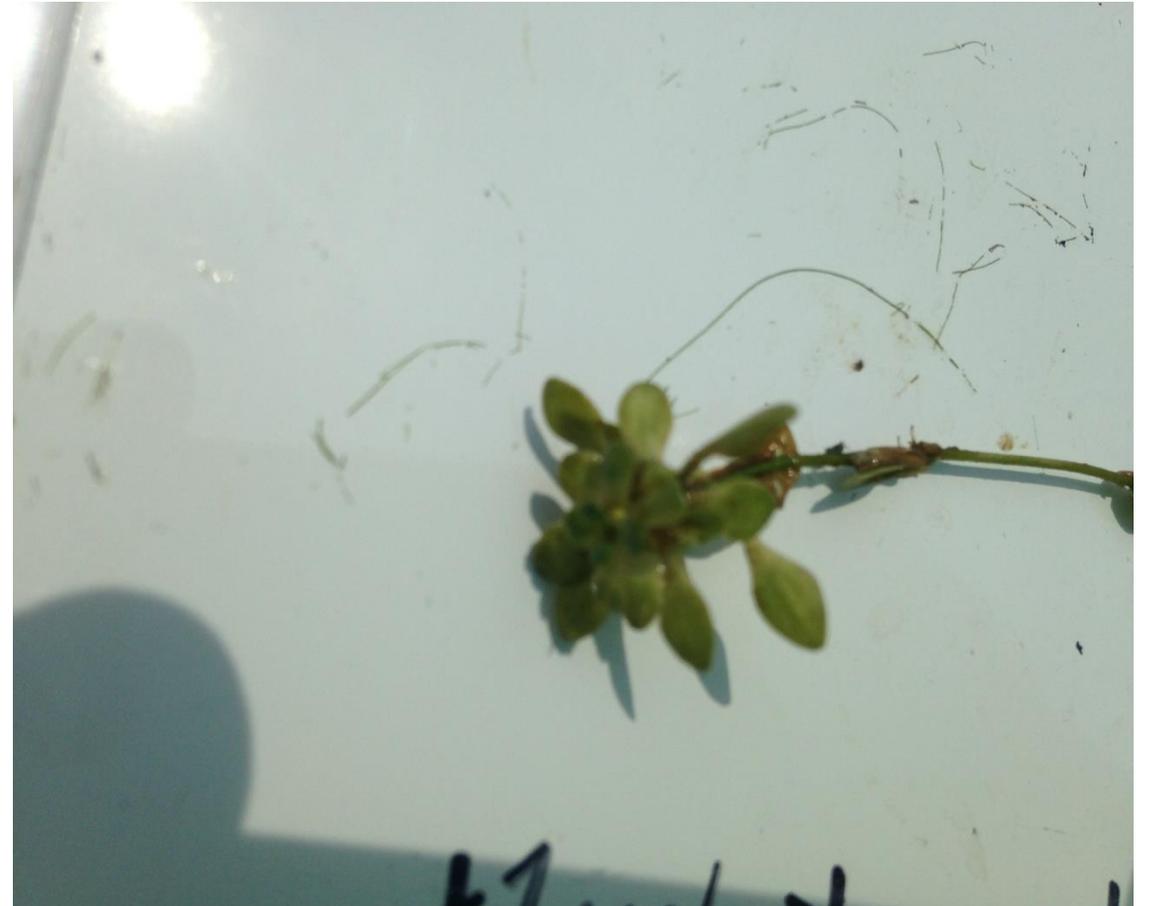
# Callitriche Stagnalis

- Characterization
  - Floating leaves
    - Opposite
    - Spoon or oval shaped
  - Submerged leaves
    - Narrower than floating leaves (picture on following slide)

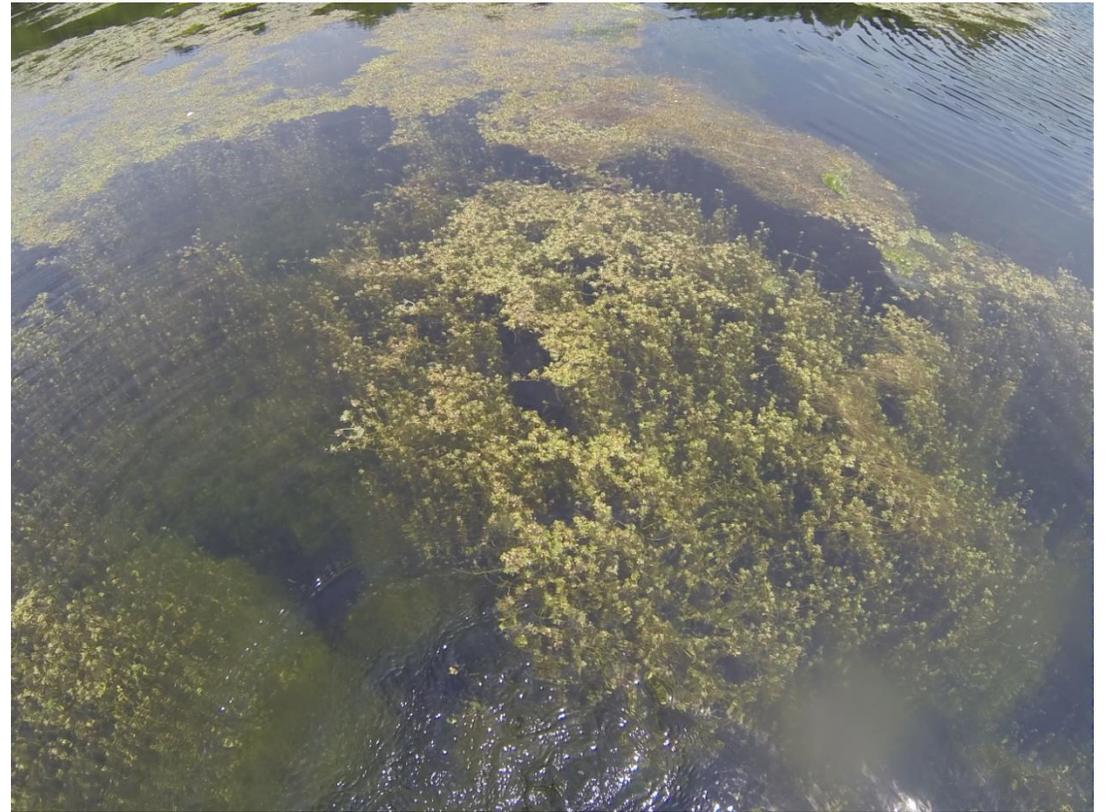
# Callitriche sp. Observed Density

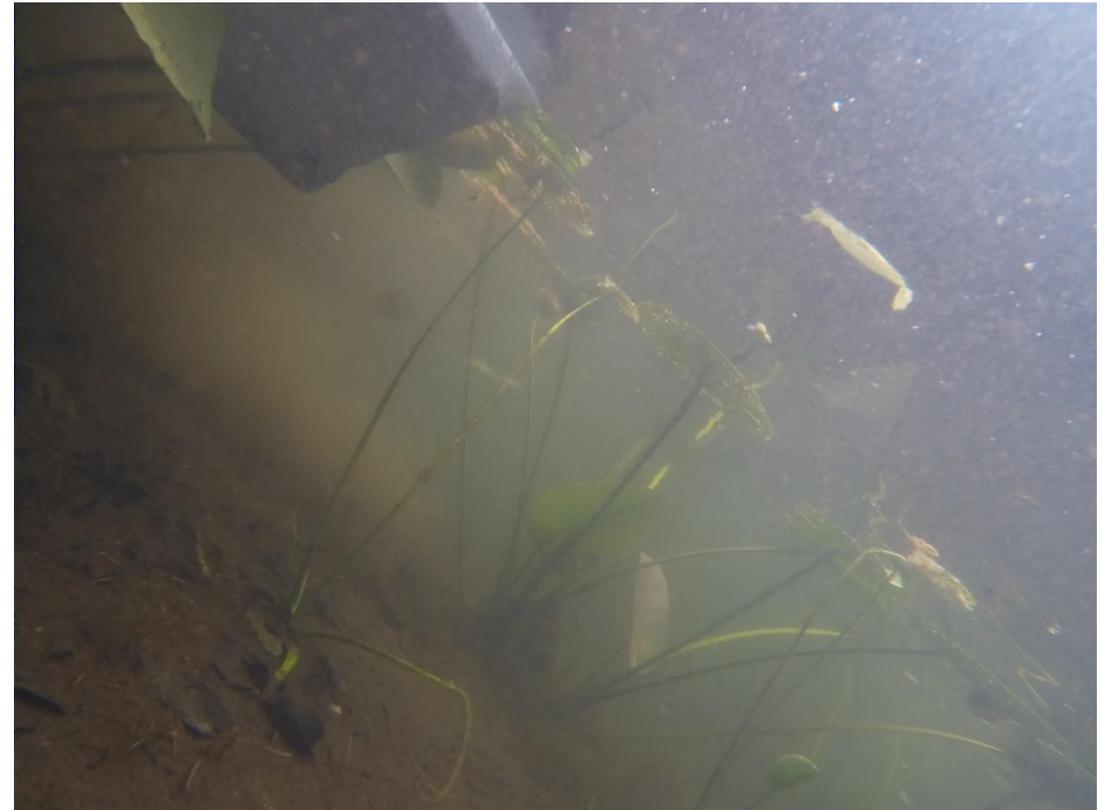
# Underwater Photo

- Photo depicting sparse submerged vegetation.

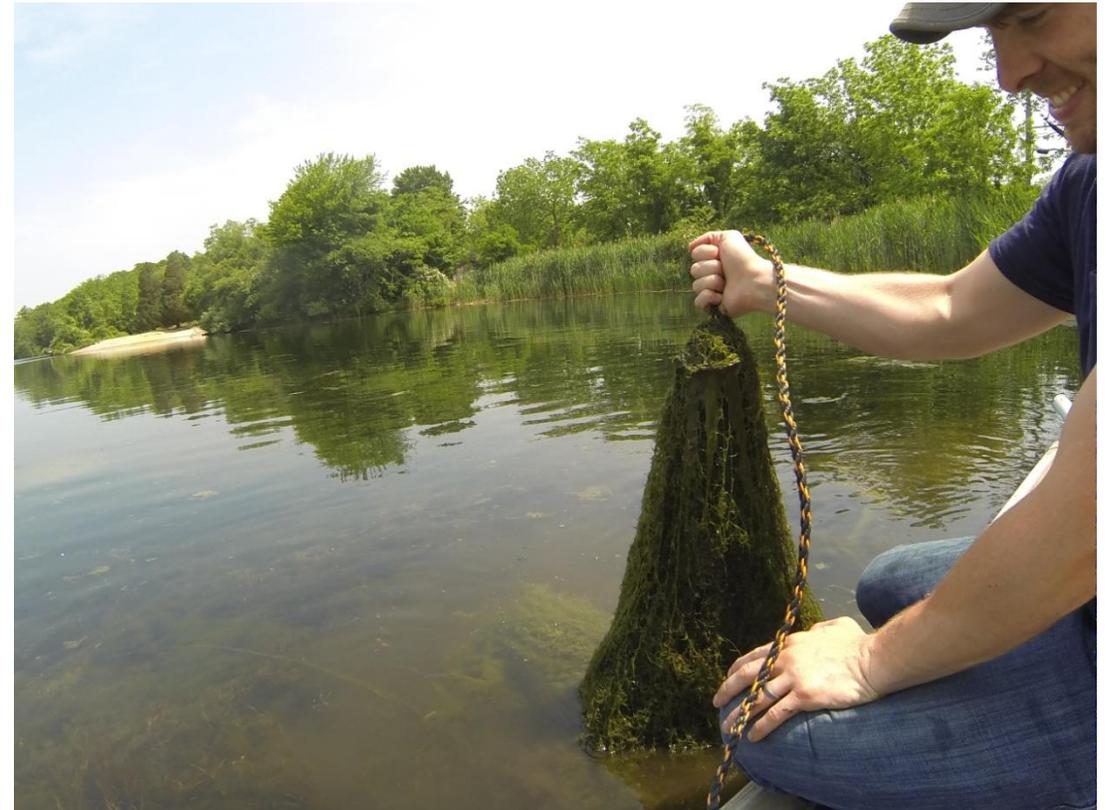
# Chara Vulgaris

- Green algae species
- Appears to have taken a very dominant role in the southern half of the lake post dredging.
- Quadrant P-3 rake toss filled with Chara Vulgaris.

- A large portion of invasive aquatic plant species were removed from the lower portion of the lake; however, as a likely results, a dense growth of the native green algae species *Chara Vulgaris* has established itself throughout the lower portion of the lake.

- Annual monitoring for the next three to five years to document aquatic plant communities in the lake.
- Consider a pilot scale Diver Assisted Suction Harvesting (DASH) project to selectively remove invasive plants.
- Monitor Suffolk County's project to remove sediment and invasive species from Canaan Lake in Patchogue in order to apply lessons learned to future Town projects such as Lower Yaphank Lake.
- Contact Suffolk County DPW to determine the status of repairs to the low level outlet at Lower Yaphank Lake; once repaired the low level outlet may allow additional options to address invasive aquatic plants in the lake to be considered.
