TOWN OF BROOKHAVEN

Mill Road Culvert Preliminary Hydraulic Analysis Report

April 6, 2018

DAM EVALUATION REPORT

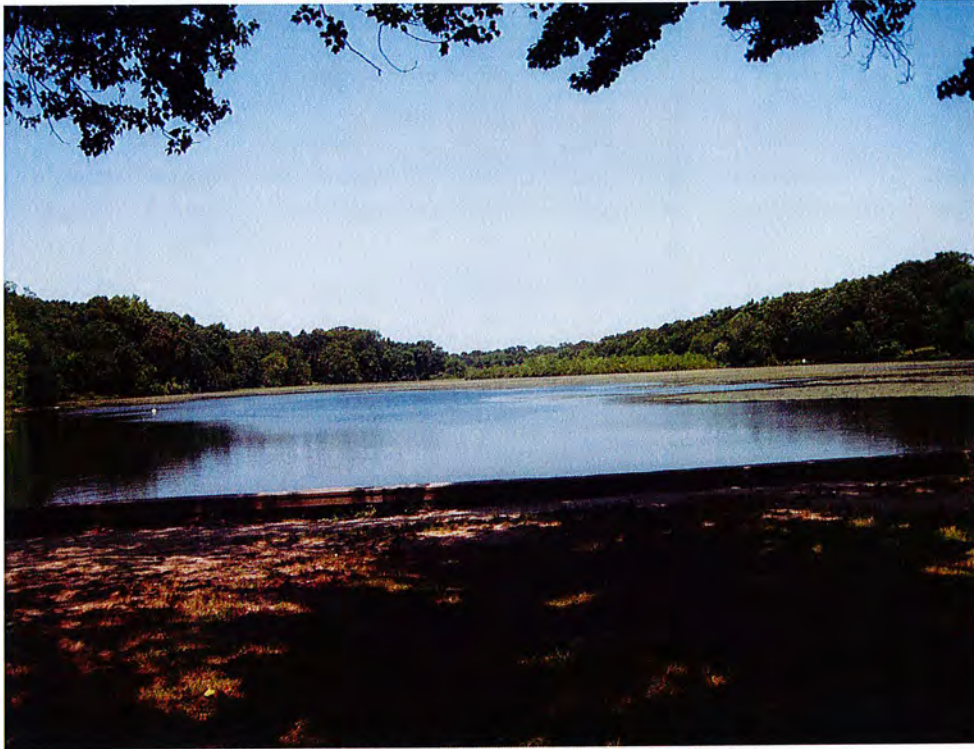
Photo # 1: Willow Lake Dam and Impoundment

The Willow Lake Dam is an earthen embankment dam located at the downstream end of Willow Lake (Photo 1). The dam consists of an earth embankment, spillway, and a low level outlet. The dam is within a municipal park with extensive public access and use. The Carmans River watershed upstream of the dam is approximately 70 square miles.
